## ROOT CAUSE FAILURE ANALYSIS FOR THE NOZZLE SIDE OF SHELL AND TUBE TYPE HEAT EXCHANGER

Ali Farokhi Nejad \*, Mohd Nasir bin Tamin  
Faculty of Mechanical Engineering, Universiti Teknologi Malaysia,  
81310 UTM Johor Bahru, Johor, Malaysia.  
\* Corresponding author: farokhi@utm.my

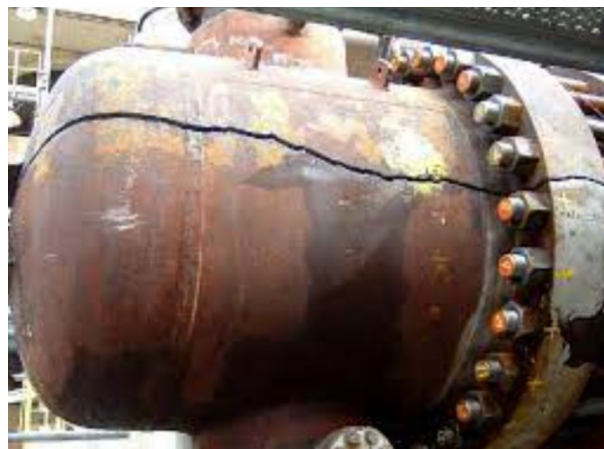
Figure 1: Nozzle side failure of a shell and tube heat exchanger.
